**Major Earthquakes in
California and the
Development of Seismic
Safety in Bridge Design**

March 2007

By Kevin J. Thompson
Caltrans State Bridge Engineer

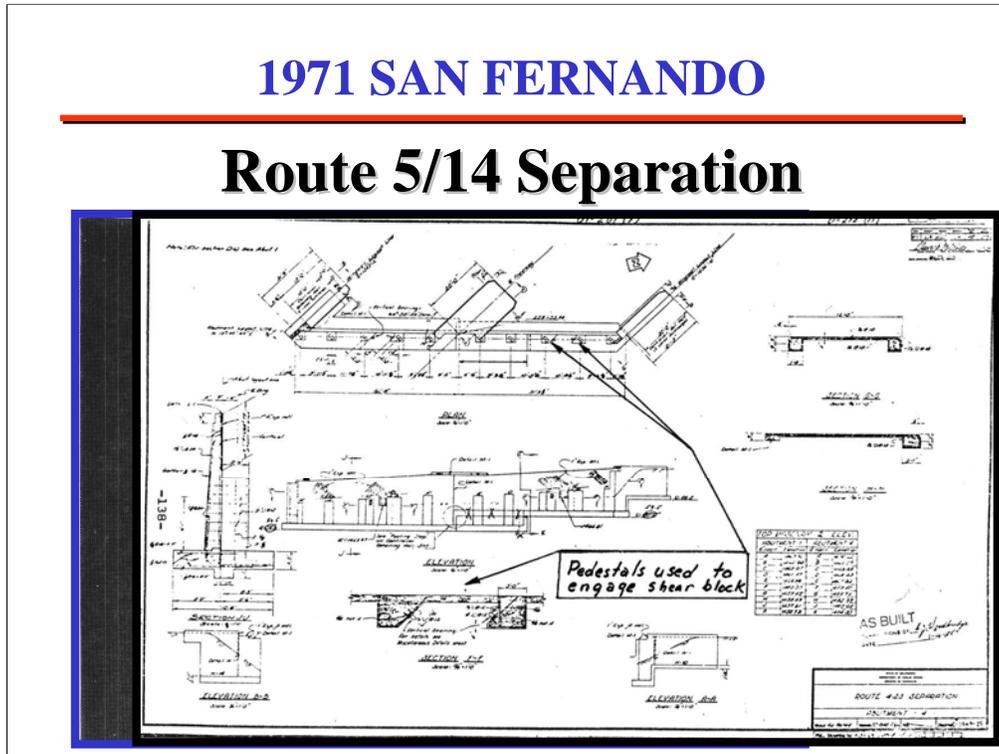
Route 5/14 Separation

1. Damage was limited to the abutment locations.
2. Large transverse forces caused the bearing pedestals to fail as they engaged the shear blocks.
3. Columns were not damaged.
4. Superstructure was not damaged.

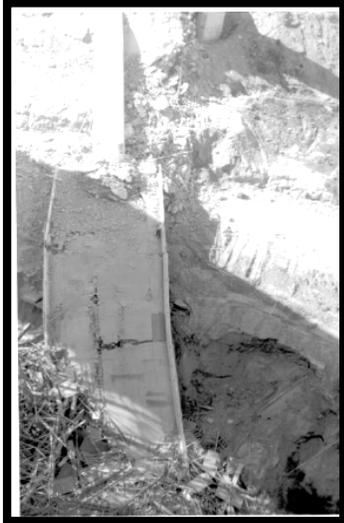
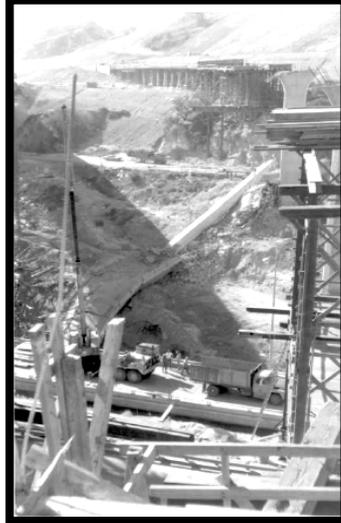
South Connector Overcrossing

1. The cause of collapse was due to longitudinal displacement of the superstructure and unseating at the hinge locations.
2. Evidence at the site show that Span 4 fell first, then Pier 4 fell on Span 4 and finally, Span 3 fell on pier 4.
3. After superstructure became unseated, the cantilever section drooped and hinged at the top of column 4, then broke off and dropped nearly straight down.

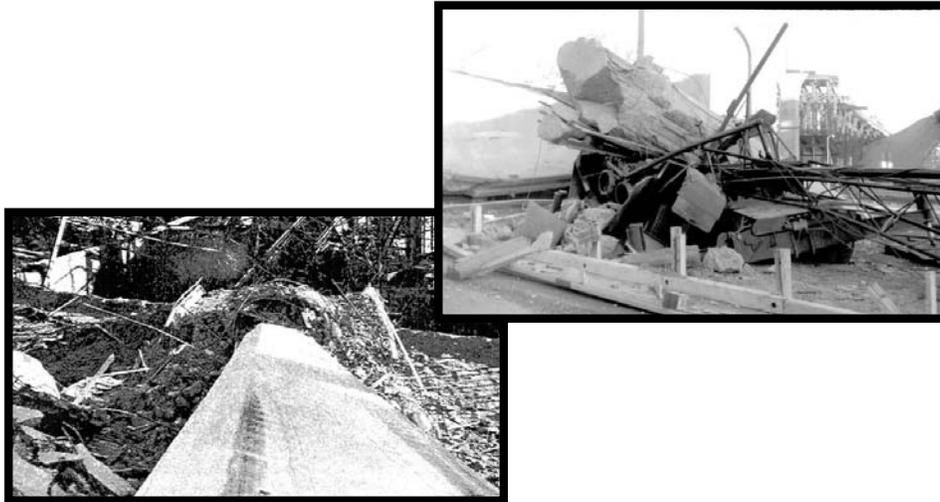
South Connector Overcrossing

1. This slide shows a close look at column 4.
2. (Bottom Left) shows a view of the superstructure (Span 3) as seen from the top of pier 4 column.
3. (Top Right) shows the top of Pier 4 column. Note fractured #18 Column reinforcement. Also, note the smooth surface on top of the column, this is the construction joint and not the deck.

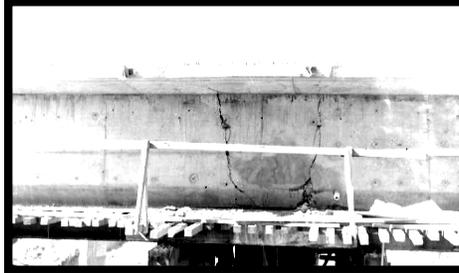
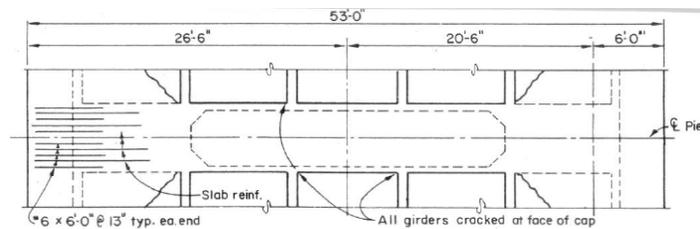
Route 5/14 Separation & O.H.

1. Note cracking of incomplete caps, which occurred in Piers 2 and 3. The 45° crack extends through the soffit and exterior girders (slab and soffit only)

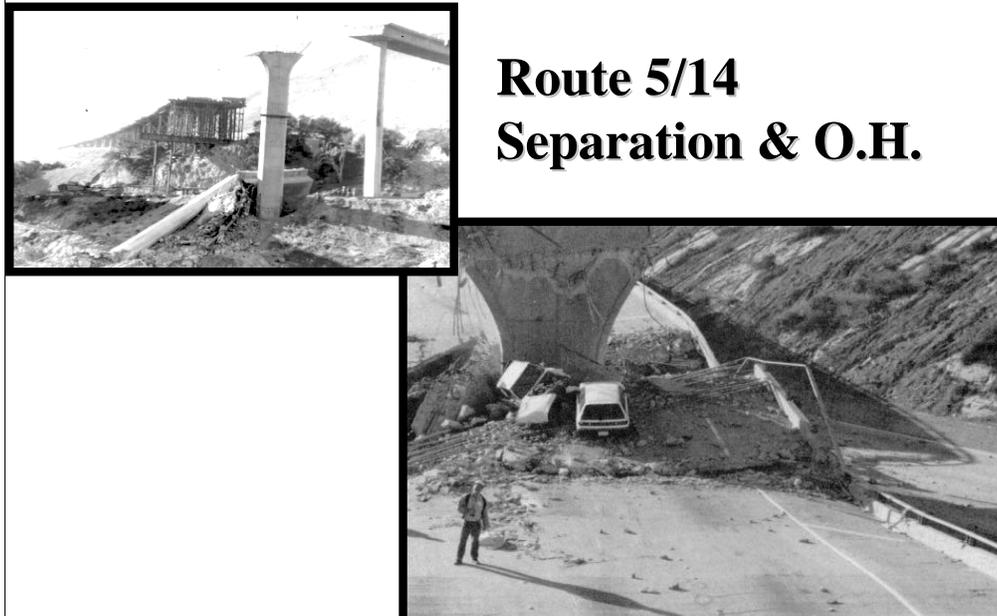
1. Note Column 6 damage from south connection.
2. (Top Left) Spans 1, 2, and 3 falsework are visible in the background.
3. (Bottom Right) The structure shown here on falsework will later collapse in the Northridge Earthquake (23 years later).
4. The column visible in the top left with falsework was from 1971. The same column is shown bottom right after Northridge in 1994.

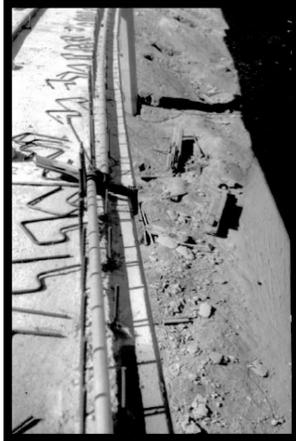
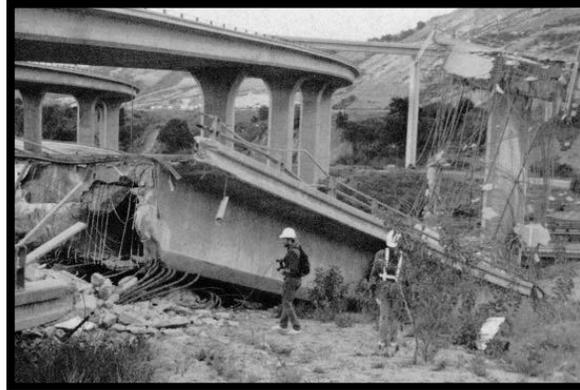
North Connector Overcrossing

1. Left slide shows movement did occur in the North Connector at the time of 1971 San Fernando Earthquake as shown.
2. Right slide shows how this structure later collapsed in the Northridge Earthquake as shown above.
 - Pier 2 failed
 - Restrainers at hinge 1 failed
 - Pier 2 was significantly shorter (stiffer) than adjacent piers 3 and 4

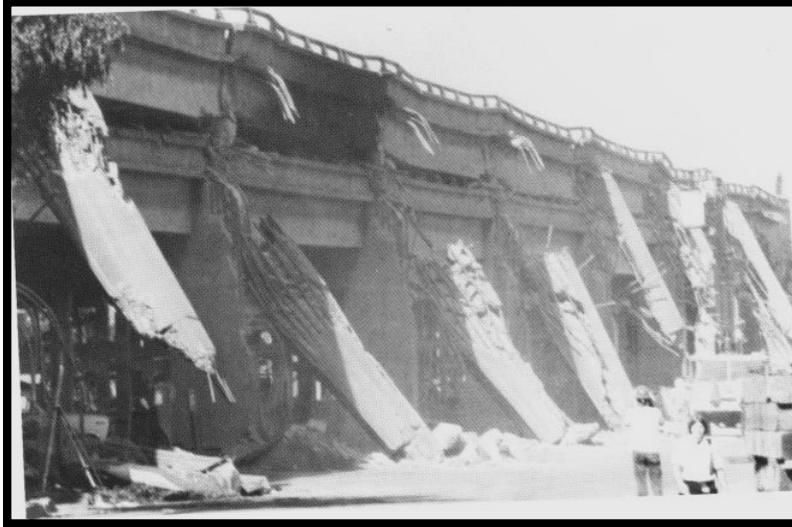
1. View of several bents that collapsed on the Cypress Viaduct.
2. The Seismic Advisory Board report “Competing Against Time” notes these as Type B1 Bents.

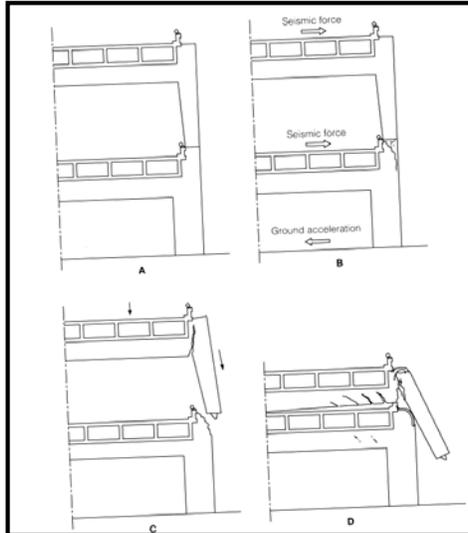
Typical Failure Sequence

1. This shows the typical failure sequence for a Type B1 Bent.
2. Conclusions (pp 188 Competing Against Time)
 - A. Analyses and design of the Cypress Viaduct performed between 1949 and 1954 had little design information available on dynamic effects, realistic ductile design, and ductile details.
 - B. Design of the Cypress Viaduct was in conformance at the time, but today, we can identify deficiencies:
 - Structure lacked redundancy
 - Structure lacked ductility (confinement, development, etc.)
 - Lack of capacity to absorb energy
3. Longitudinal restrainers helped, but did not address column ductility.

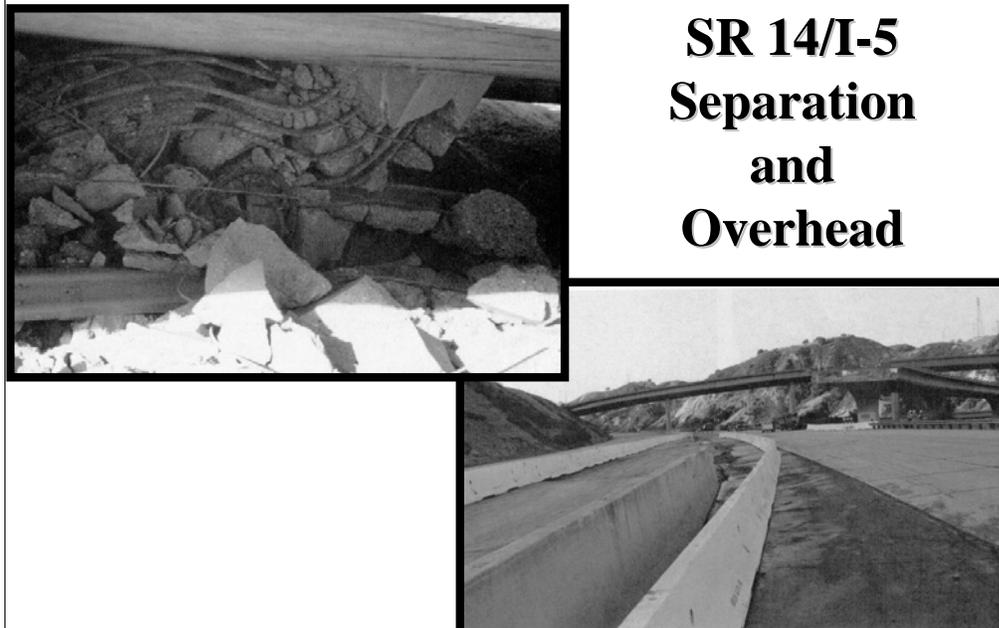
SR 14/I-5 Separation and Overhead

1. Top Left: Short column failure of the 14/I-5 Separation and Overhead. This is Pier #2
2. Bottom Right: Shows completed demolition. (Spans 1, 2, and 3 and piers 2 and 3 removed)

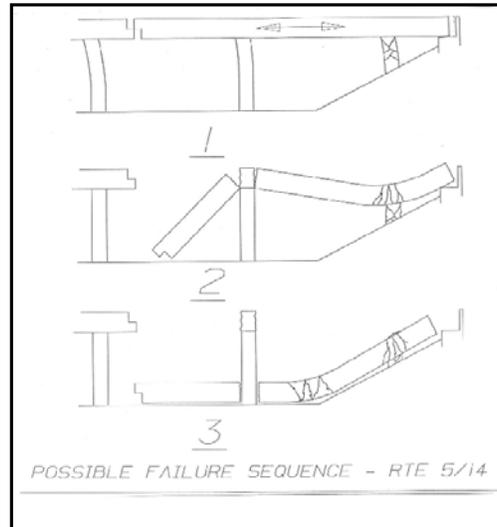
1. This shows the probable sequence of collapse of the 14/I-5 Separation and Overhead.
 - Short stiff column next to abutment fails
 - Unseating of hinge
 - Spans collapse

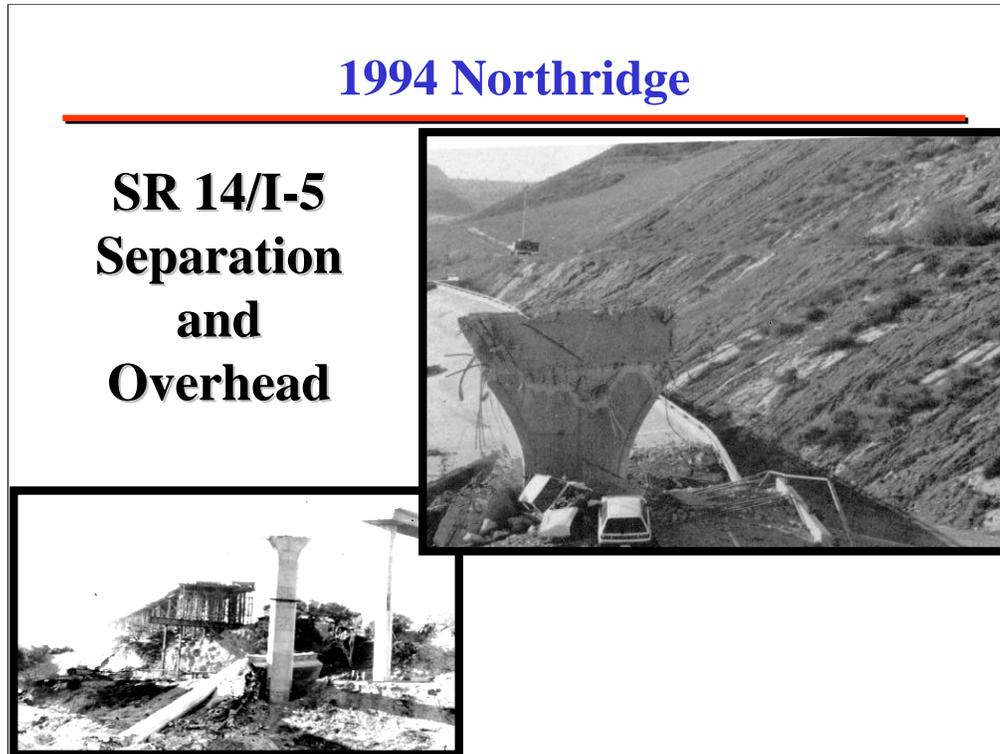
1. Top Right shows the 1994 Northridge collapse of the 14/I-5 Separation and Overhead.
2. Bottom Left - Repeating an earlier slide of 5/14 Separation and Overhead (1971 San Fernando Earthquake).
3. A common misconception following the Northridge Earthquake was that structures that collapsed during the 1971 San Fernando Earthquake collapsed again during the Northridge Earthquake:
 - 1971 collapse was in a different separation structure.
 - The two bridge sections that collapsed in the Northridge earthquake were under construction during the 1971 San Fernando Earthquake.
 - All columns were complete during the 1971 Earthquake and had pre-1971 details (#4 @ 12 transverse column reinforcement)

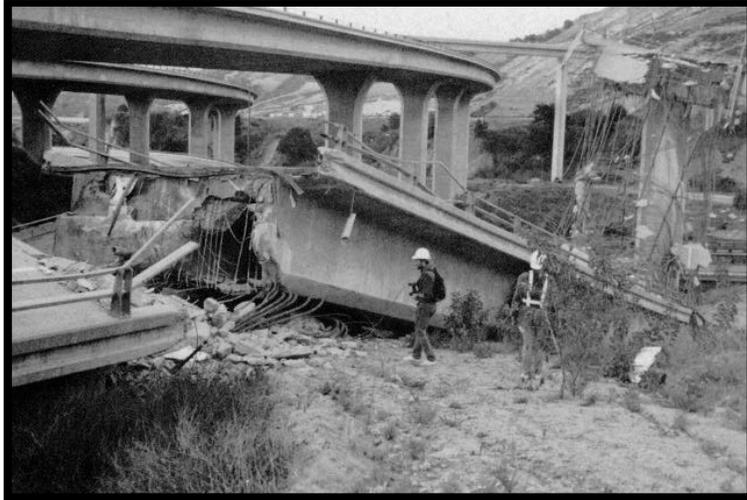
SR 14/I-5 North Connector Overcrossing

1. This slide shows the collapse of the North Connector Overcrossing.
2. Both the 14/I-5 Separation and Overhead and the North Connector Overcrossing bridge failures can be attributed to brittle shear failure of short stiff columns.
3. These columns, proportional to their stiffness, attracted more force than their more flexible adjacent bents.
4. Which column failed
 - Pier 2 failed
 - Restrainers at hinge 1 failed
 - Pier 2 was significantly shorter (stiffer) than adjacent piers 3 and 4

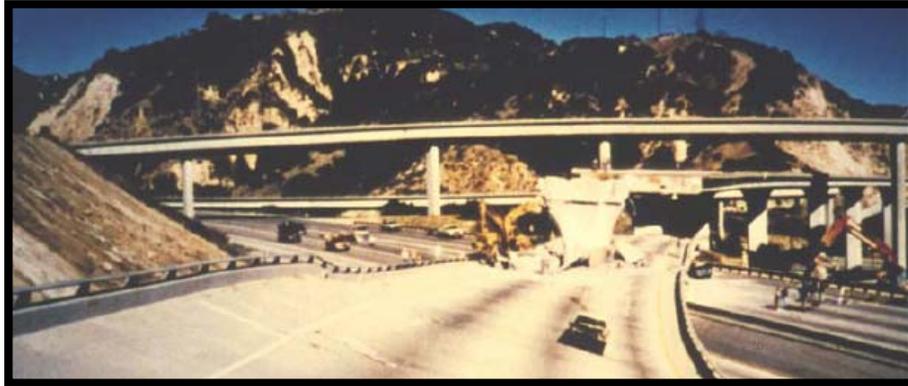
5/14 Interchange

Shows collapsed end spans of the 14/I-5 Separation and Overhead over I-5 in the Northridge Earthquake.

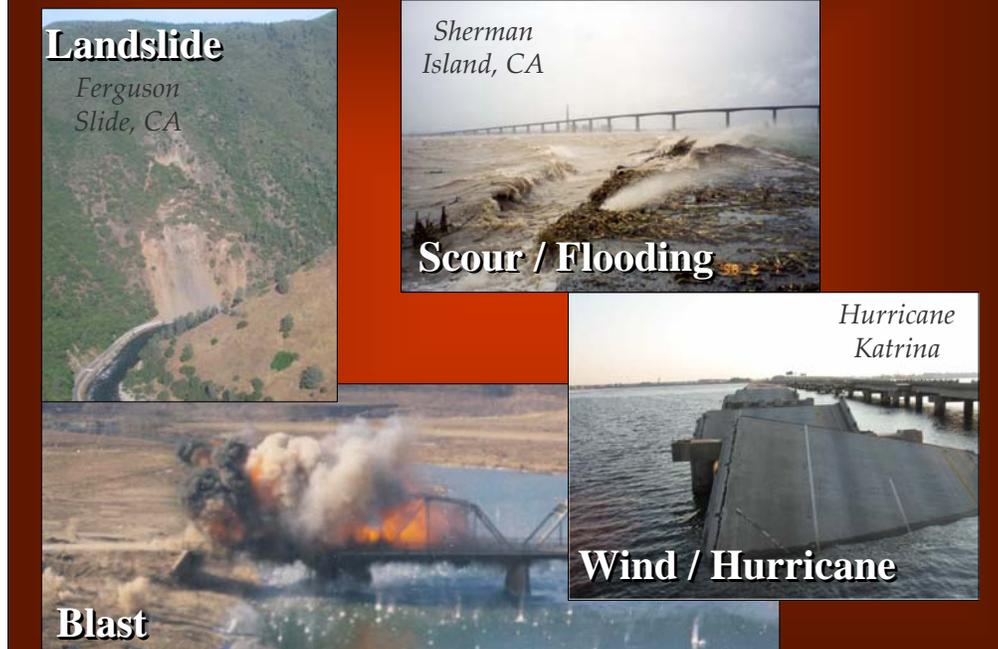
LANDSLIDE: FERGUSON SLIDE (Hwy 140), CA - April 2006

Rock slide and material began sliding on to State Highway 140 in the Sierra National Forest, approximately 6 miles west of Yosemite National Park. Caltrans temporarily managed to open the road to one lane, but by June 2006 the slide moved even more, closing the road completely.

SCOUR / FLOODING: SHERMAN ISLAND (Route 160), Bay Area, CA
January 2006

Overtopping of a levee adjacent to the San Joaquin River during high winds and Higher High tide.

Damage to the Biloxi-Ocean Springs bridge.
