**Major Earthquakes in
California and the
Development of Seismic
Safety in Bridge Design**

March 2007

By Kevin J. Thompson
Caltrans State Bridge Engineer

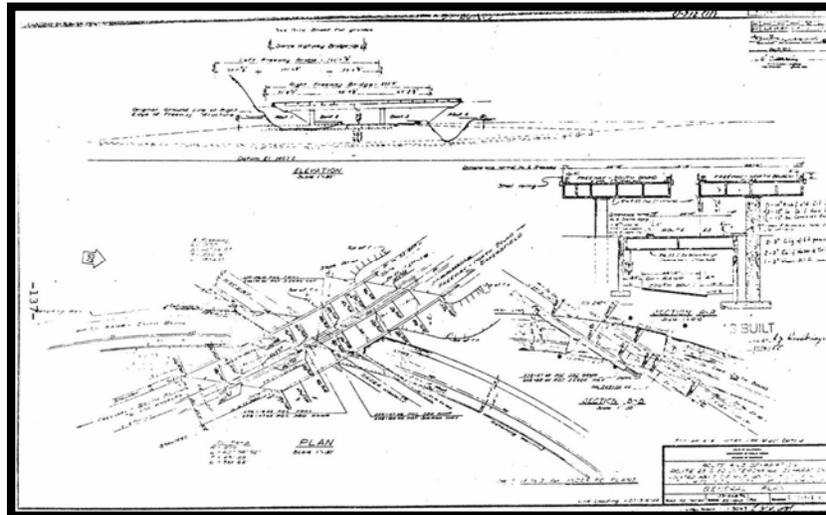
Route 5/14 Separation

1. Route 5/14 (old 4/23) Separation includes 2 bridges, R/L
2. Three span, single column, box girder type structures that were constructed in 1952.
3. Bents consist of single column 6'0" spirally reinforces columns supported on spread footing

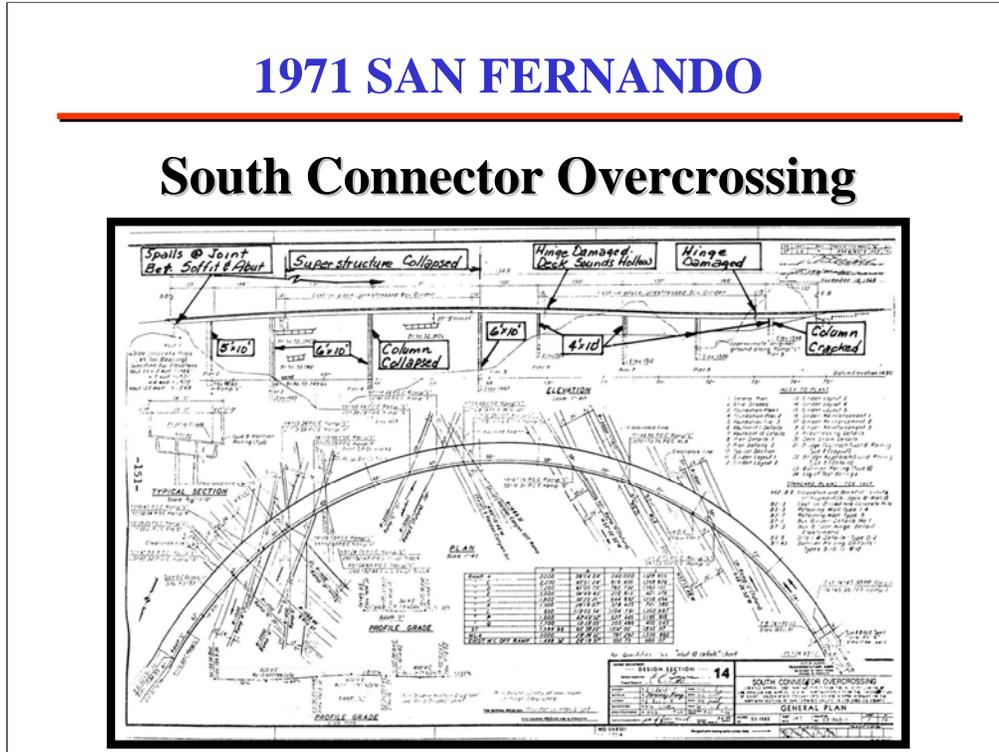
South Connector Overcrossing

1. This structure was completed at the time of the 1971 earthquake.
2. This bridge is a 1349 ft., single column box girder structure; construction complete at time of earthquake.
3. Combination of CIP pre-stressed frames and conventionally reinforced frames
4. Minor damage to abutments.
5. Piers 2, 3, 5, 6, 7 and 8 had no damage. Pier 9 had a longitudinal “X” crack.
6. Column 4 and the superstructure in Span 3 and 4 collapsed. (Collapse due to unseating of the hinge)
7. Note Pier #9 “cracked”! We will talk more about short stiff columns and balanced stiffness later!
- 8.

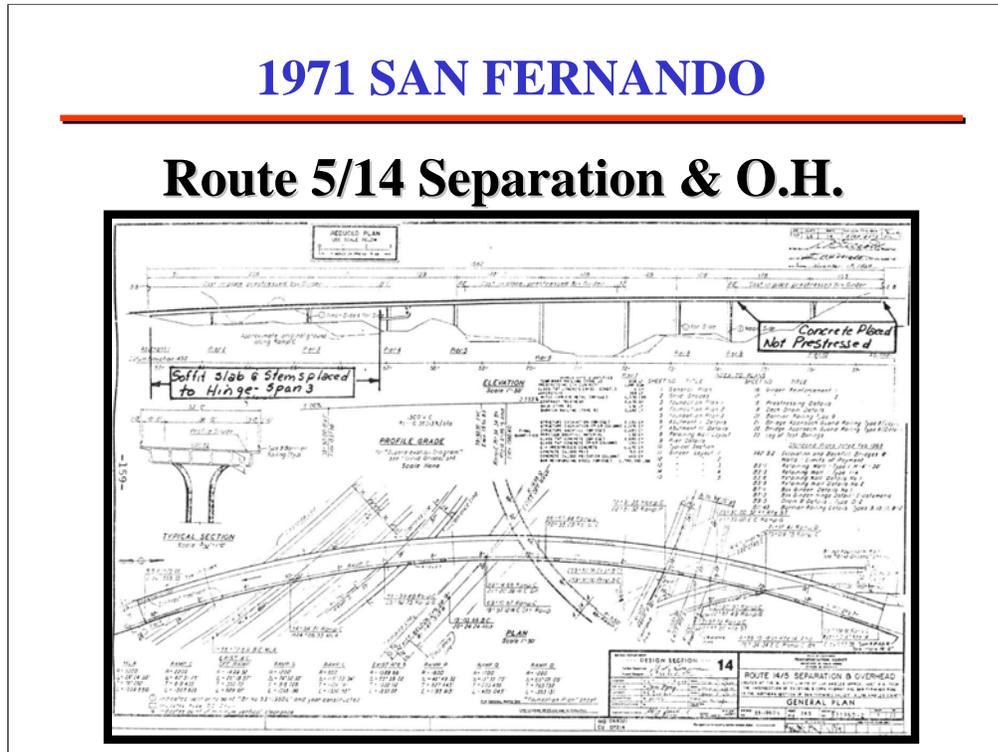
Route 5/14 Separation & O.H.

1. The 5/14 separation and OH is a 1582' single column, box girder type structure with both cast-in-place pre-stressed and conventionally reinforced concrete.
2. At the time of the earthquake, the bottom slab and stem had been placed from Abut 1 to hinge in Span 3.
3. Also, at the time of the earthquake, the concrete from the hinge in Span 9 to Abut had all been placed, but no pre-stressing had been done.
4. At the time of the earthquake, no other superstructure concrete had been placed.
5. Most of the damage to concrete was due to settlement of falsework.
6. This structure later collapsed in the Northridge Earthquake which will be discussed later.

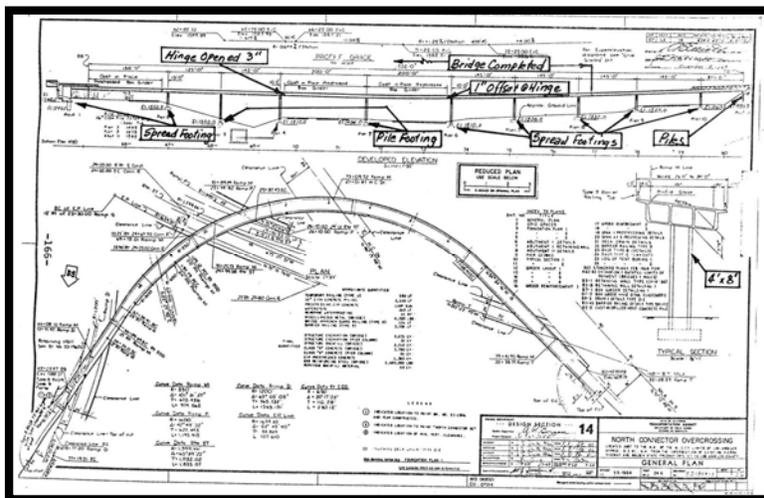
North Connector Overcrossing

1. The structure is a 1532' single column box girder type structure that was completed up to the hinge of Span 8. Damage to this structure was minor.
2. The structure is oriented similar to the South Connector, only 400' North.
3. Main difference between the South & North Connectors is relative height and substructure type. North Connector is approximately 30' shorter than the South Connector.
4. Substructure Difference:
 - North Connector – Columns on footing type supports
 - South Connector – CIDH Shafts (more flexible and longer)
5. Note the first two spans of this structure collapsed during the 1994 Northridge Earthquake
 - Pier 2 failed
 - Restrainers at hinge 1 failed
 - Pier 2 was significantly shorter (stiffer) than adjacent piers 3 and 4

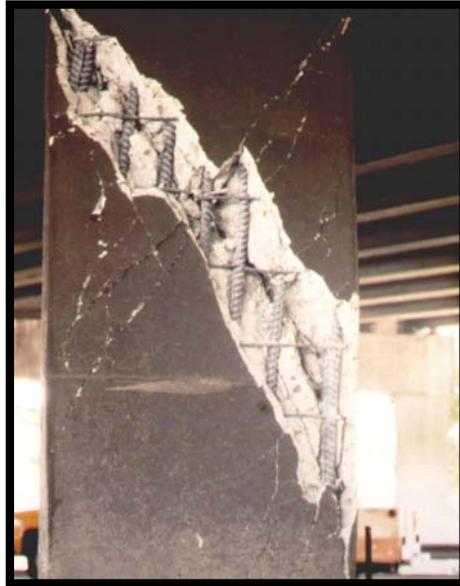
1987 WHITTIER

1. The 1987 Whittier earthquake again demonstrated the inadequacies of pre-1971 column designs.
2. There were no collapses but the damage observed led to increased emphasis on basic research into practical methods for retrofitting existing columns.

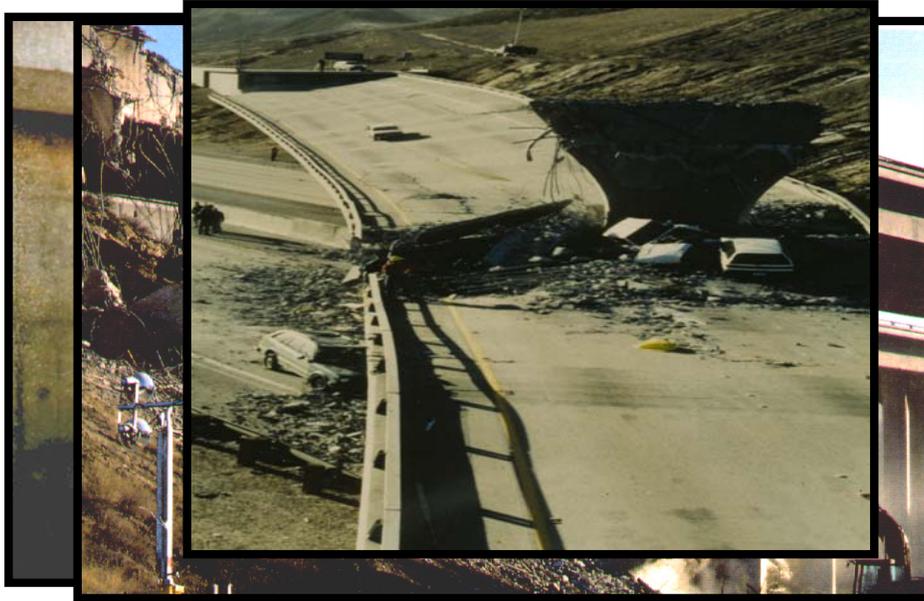
1994 NORTHRIDGE

1. The Northridge earthquake demonstrated again that there were still many seismic vulnerabilities that needed focus.
2. Retrofitted structures performed well.
3. But questions about;
 - a) near fault effects,
 - b) unbalanced frames,
 - c) vertical ground motions, and
 - d) the performance of early retrofit details surfaced and demanded attention.
4. The Phase 2 Retrofit Program, focused on multi-column bents, started in 1995 on the heels of the Phase 1 Retrofit Program.

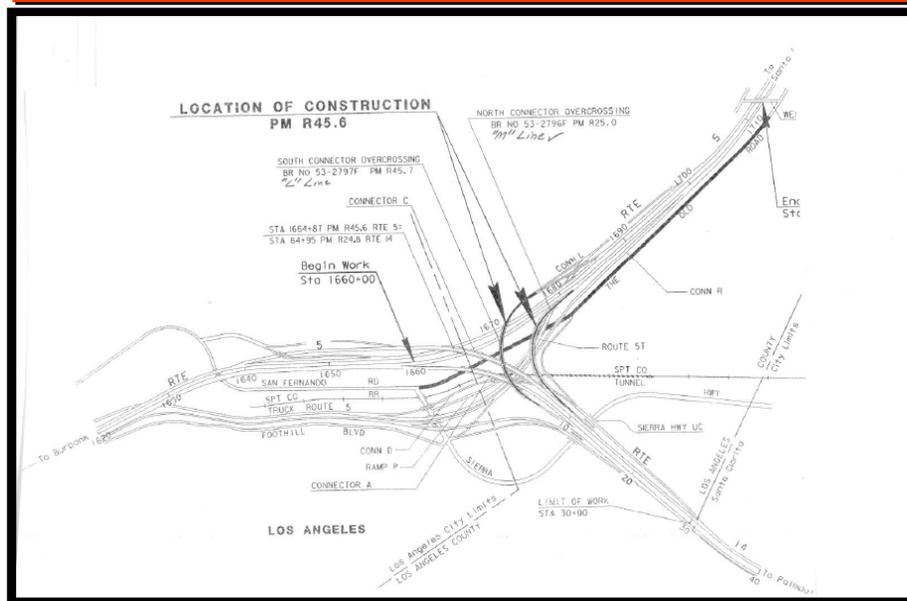
1. This is a contract plan view of the replacement structures for:
 - a. South Connector Overcrossing – damaged in Northridge, but didn't collapse
 - b. North Connector Overcrossing – partial collapse (end spans)
2. This plan view also shows that the 14/I-5 interchange is complex with several connectors in close proximity.

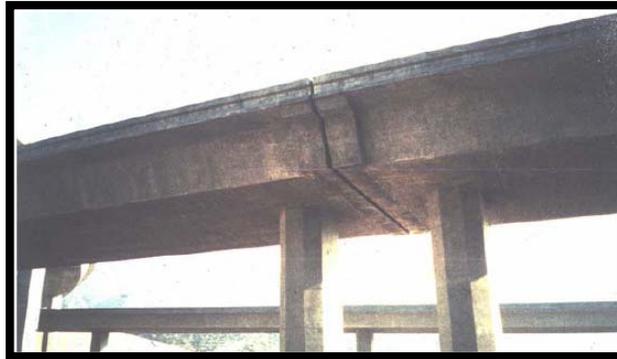
1. Top: Special Hinge
2. Bottom: Column Isolation
